Navajo Abandoned Uranium Mine

Site Screen Report

Mesa III Mine AUM Site

Navajo AUM Northern Region

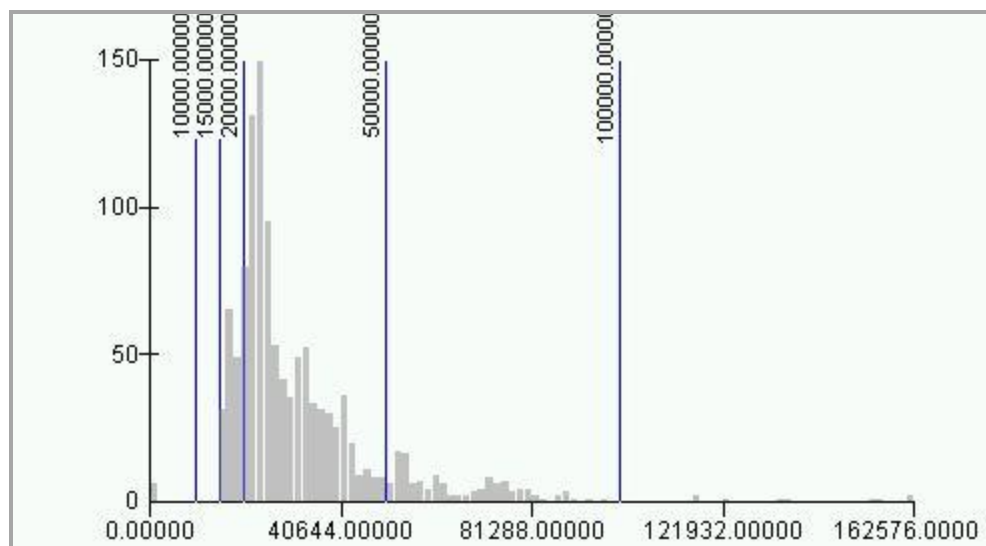
The following chart and statistics were generated by ESRI ArcGIS 9.3.1, and show the general distribution of the site gamma radiation measurements. The horizontal X axis represents the gamma radiation reading levels in cpm (lowest levels to the left). The vertical Y axis represents the frequency of each gamma radiation level.

Count:	1182
Minimum:	0.00000
Maximum:	162576.00000
Sum:	37804400.00000
Mean:	31983.41794
Median:	25648.50000
Standard Deviation:	17426.94285

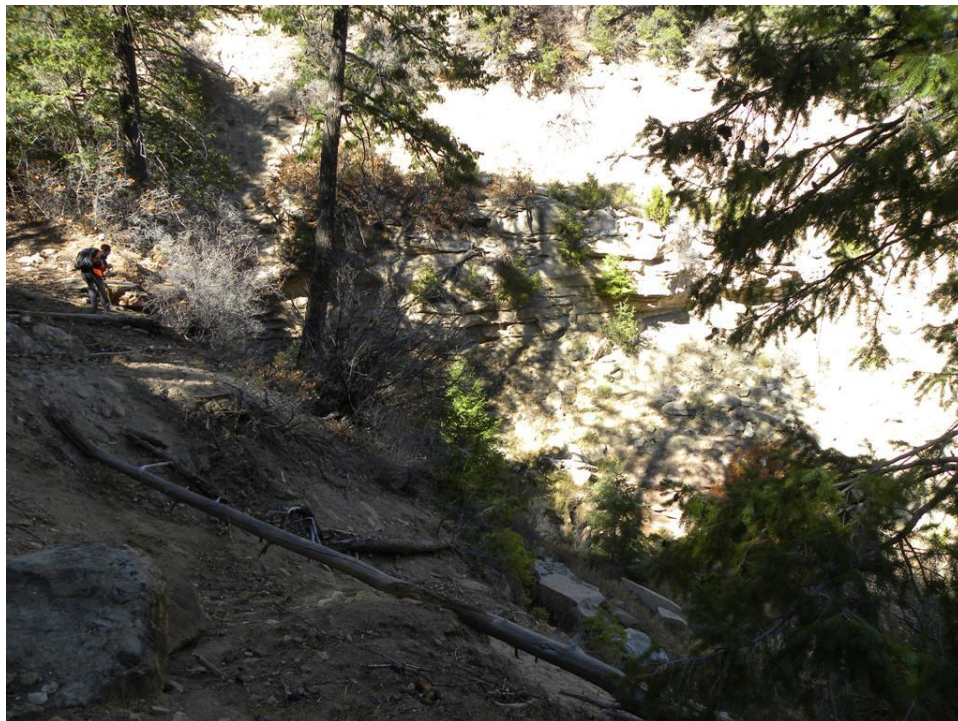
Photo 1. Mine site

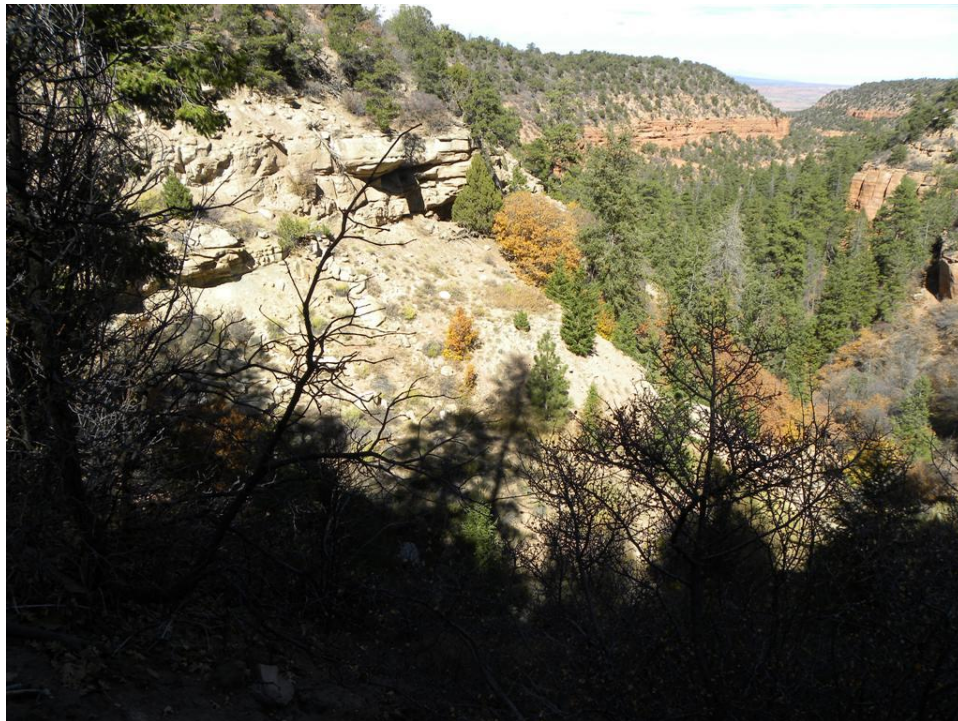
Large waste pile at the southeast end of site 100' x 50', with a total estimated volume of 926 yd³

Photo 2. Mine site and waste pile in distance

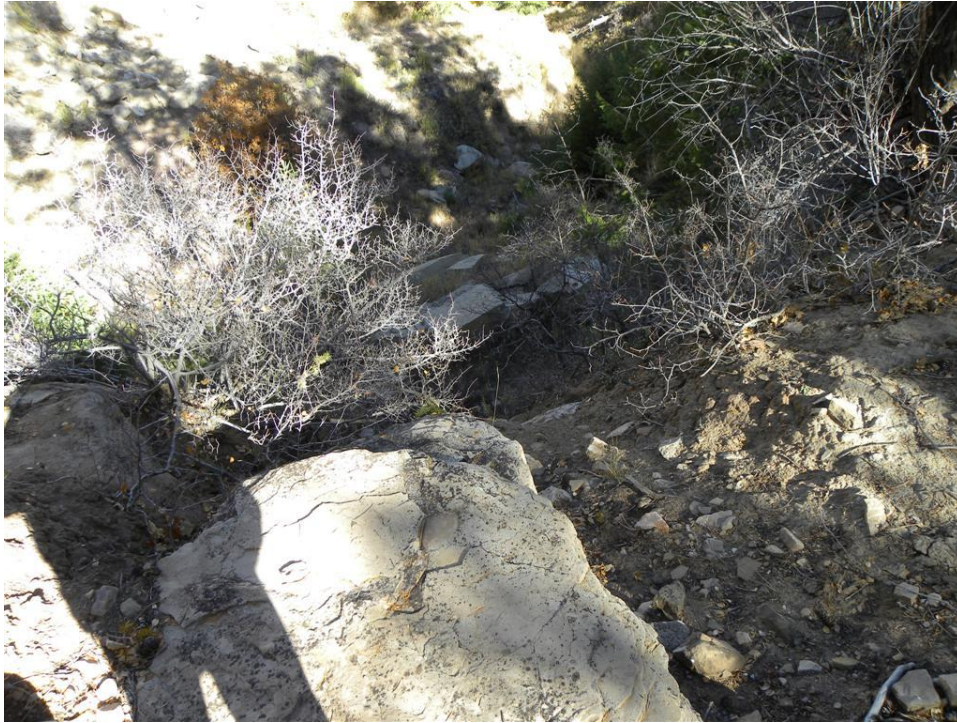
Photo 3. Mine site above adit

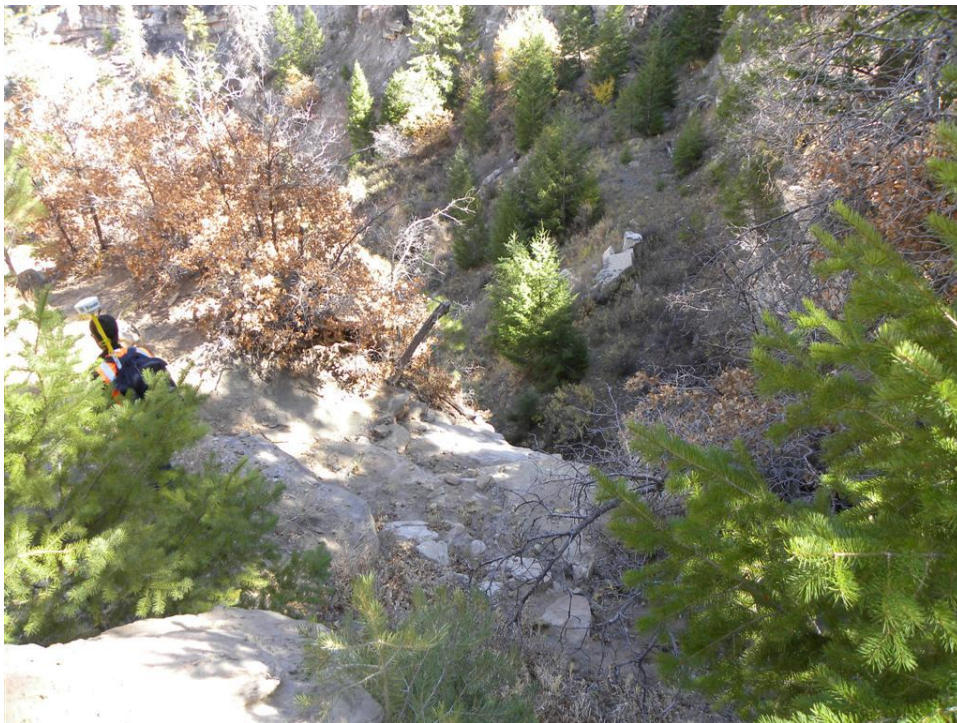
Photo 4. Mine site above adit

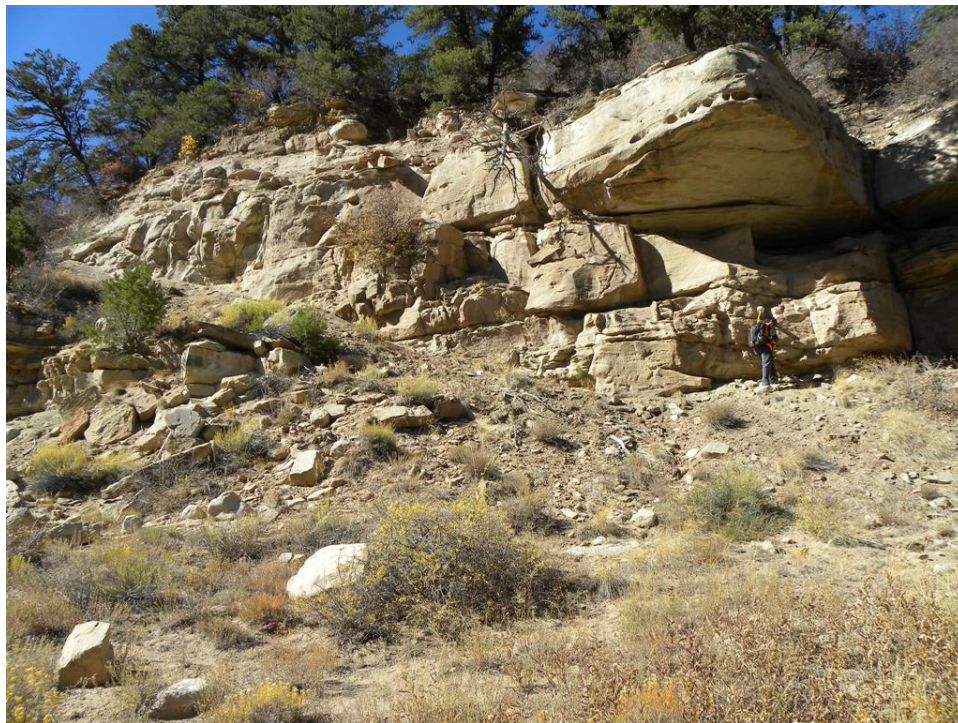
Photo 5. Waste rock

Unreclaimed waste rock and sealed adit onsite. The drainage running through the site had some running water, and starts at the. Drainage was followed until the slope became impassible, elevated readings were found throughout the drainage.

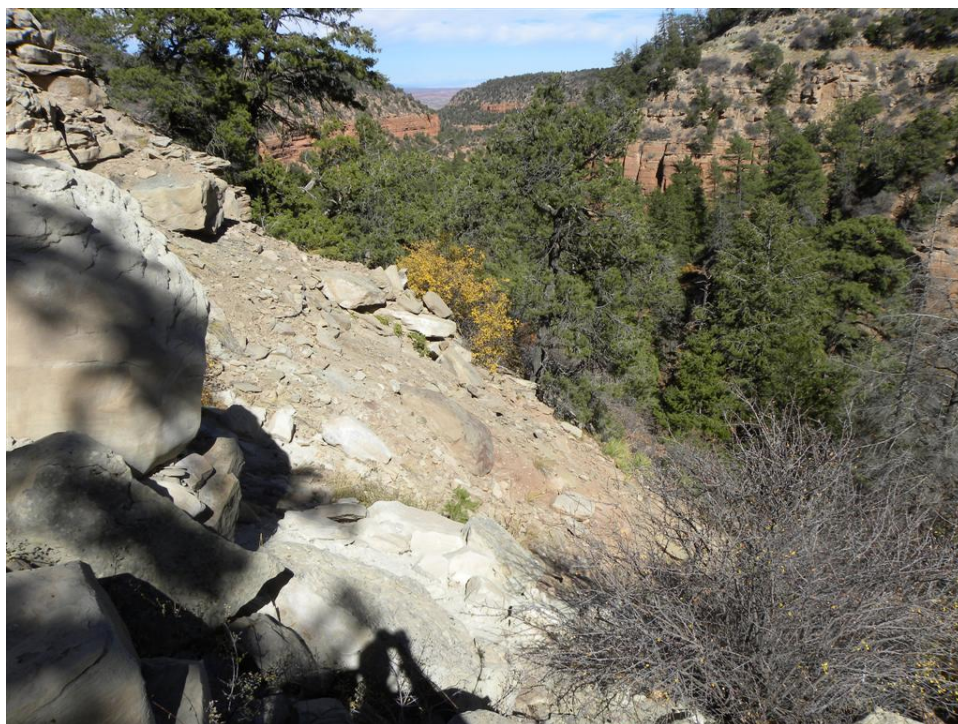
Photo 6. Waste pile

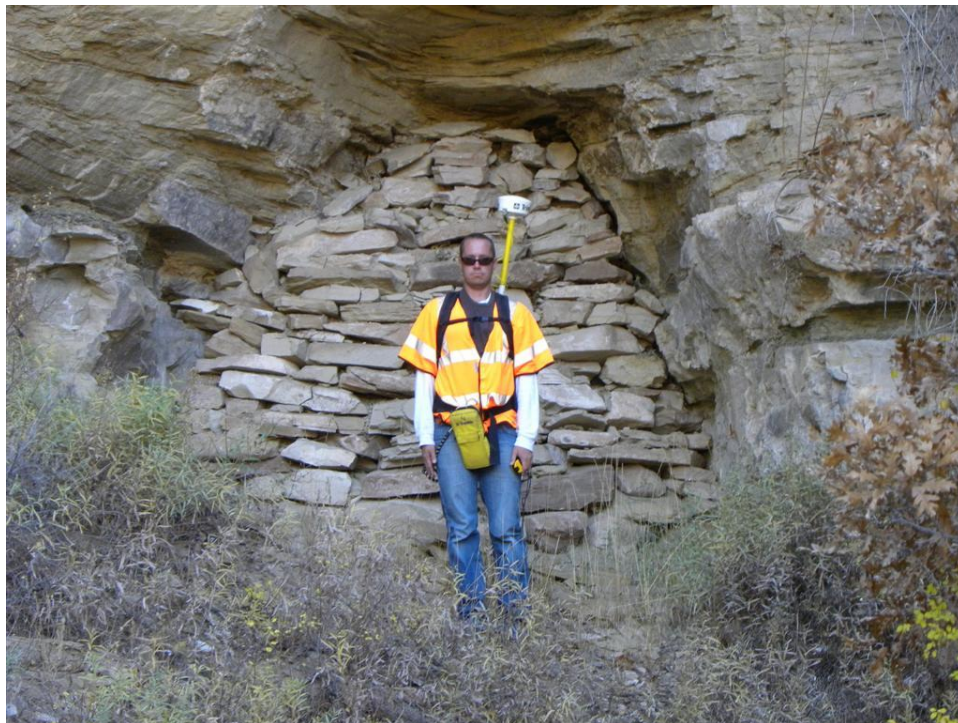
9' high x 10' wide adit, drainage below adit

Photo 7. Sealed dit

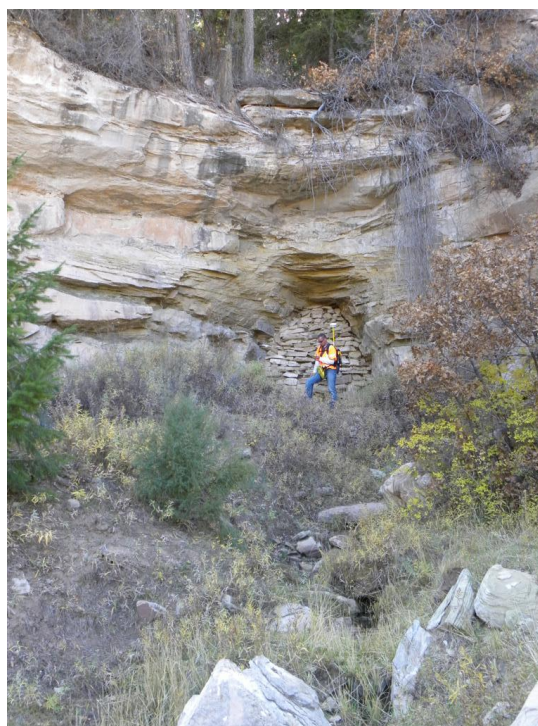
Drainage from adit runs through site and adjoining Mesa II ½, Mine 4 site, drainage was followed until the slope became impassible.

Photo 8. Sealed adit and drainage

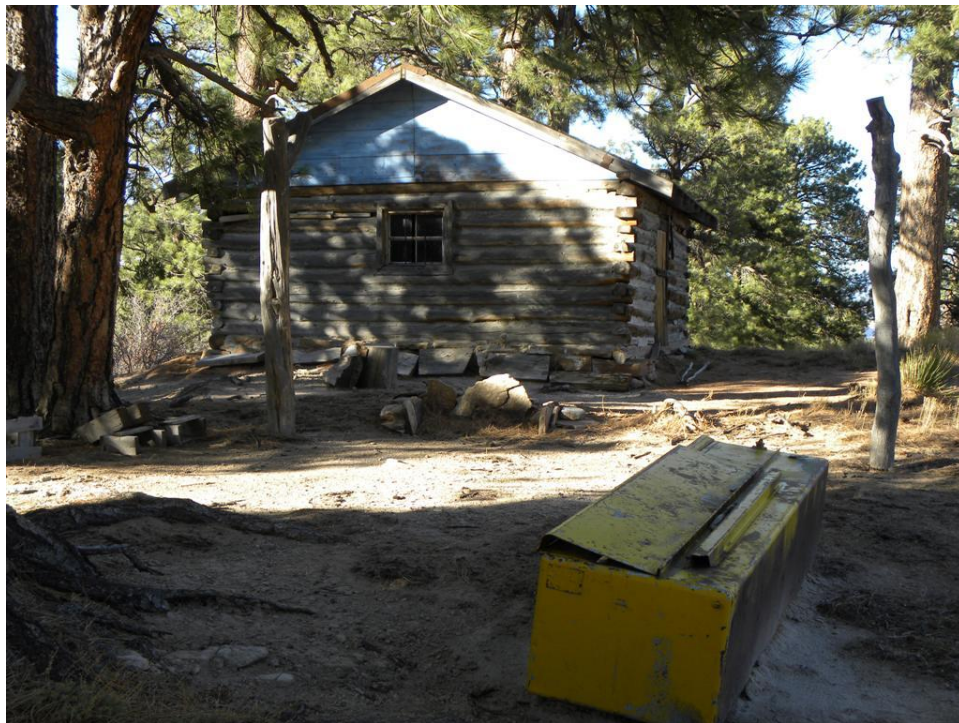
200 feet to 0.25 mile: An unoccupied house was located at the top of the mesa, approximately 0.18 miles west of the site

All gamma radiation measurements collected in the vicinity of the house were less than 11,000 cpm

Photo 9. House 0.18 miles west of site

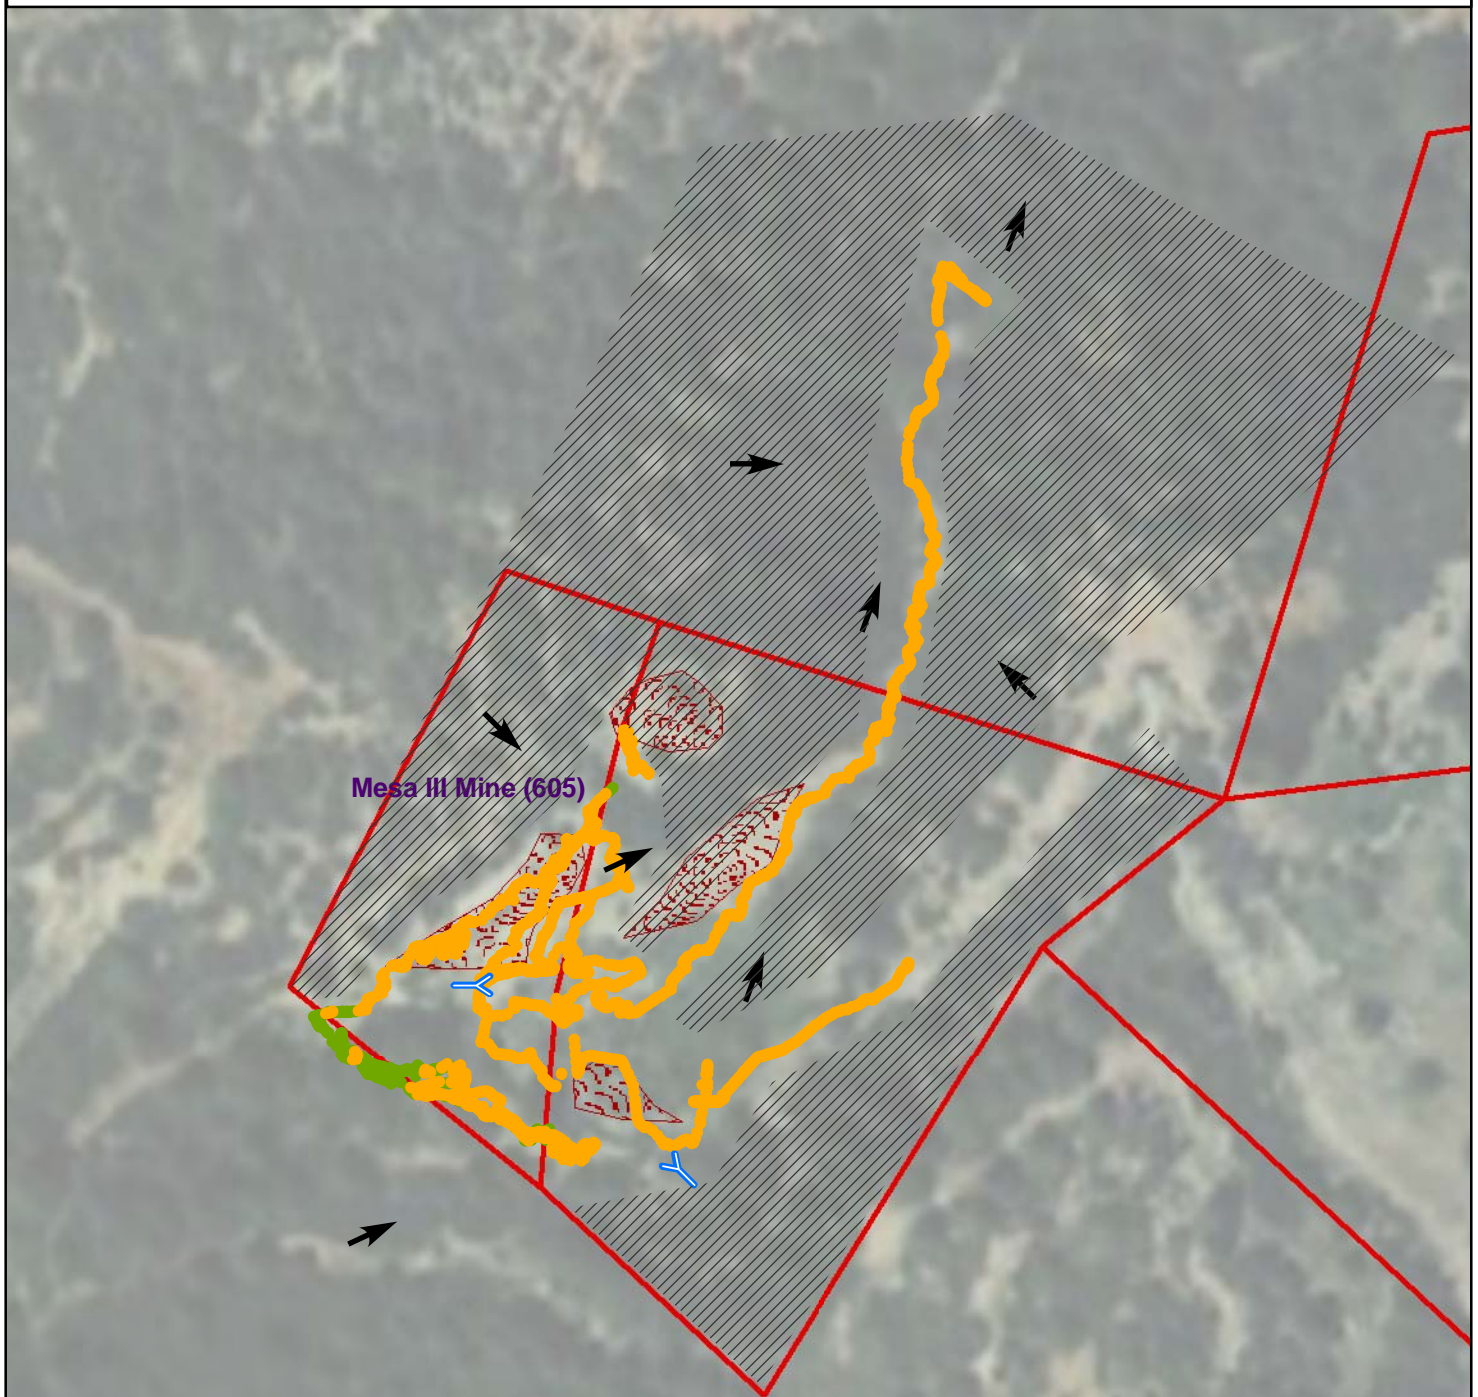
**Figure 1 - Gamma Radiation Measurements, Above Two Times Background
Mesa III Mine (605)
Cove Chapter, Navajo Nation, Arizona**

A total of 1,176 gamma radiation measurements were collected from the mine site, ranging from 14,801 cpm to 162,576 cpm. Measurements in the vicinity of the waste debris were found at levels ranging from 40,000 to 140,000 cpm, the drainage through site ranging from 137,000 - to 275,000 cpm, and the adit was approximately 90,000 cpm. The measurements are represented in Figures 1 and 2.

Note: This map includes a portion of the data collected from the screening of adjacent site Mesa II 1/2 Mine 4 (604).
The drainage stream leading from onsite adit passes directly through site 604.

Gamma survey conducted 10/2009
Measured as counts per minute (cpm)

Average background = 10,289 cpm

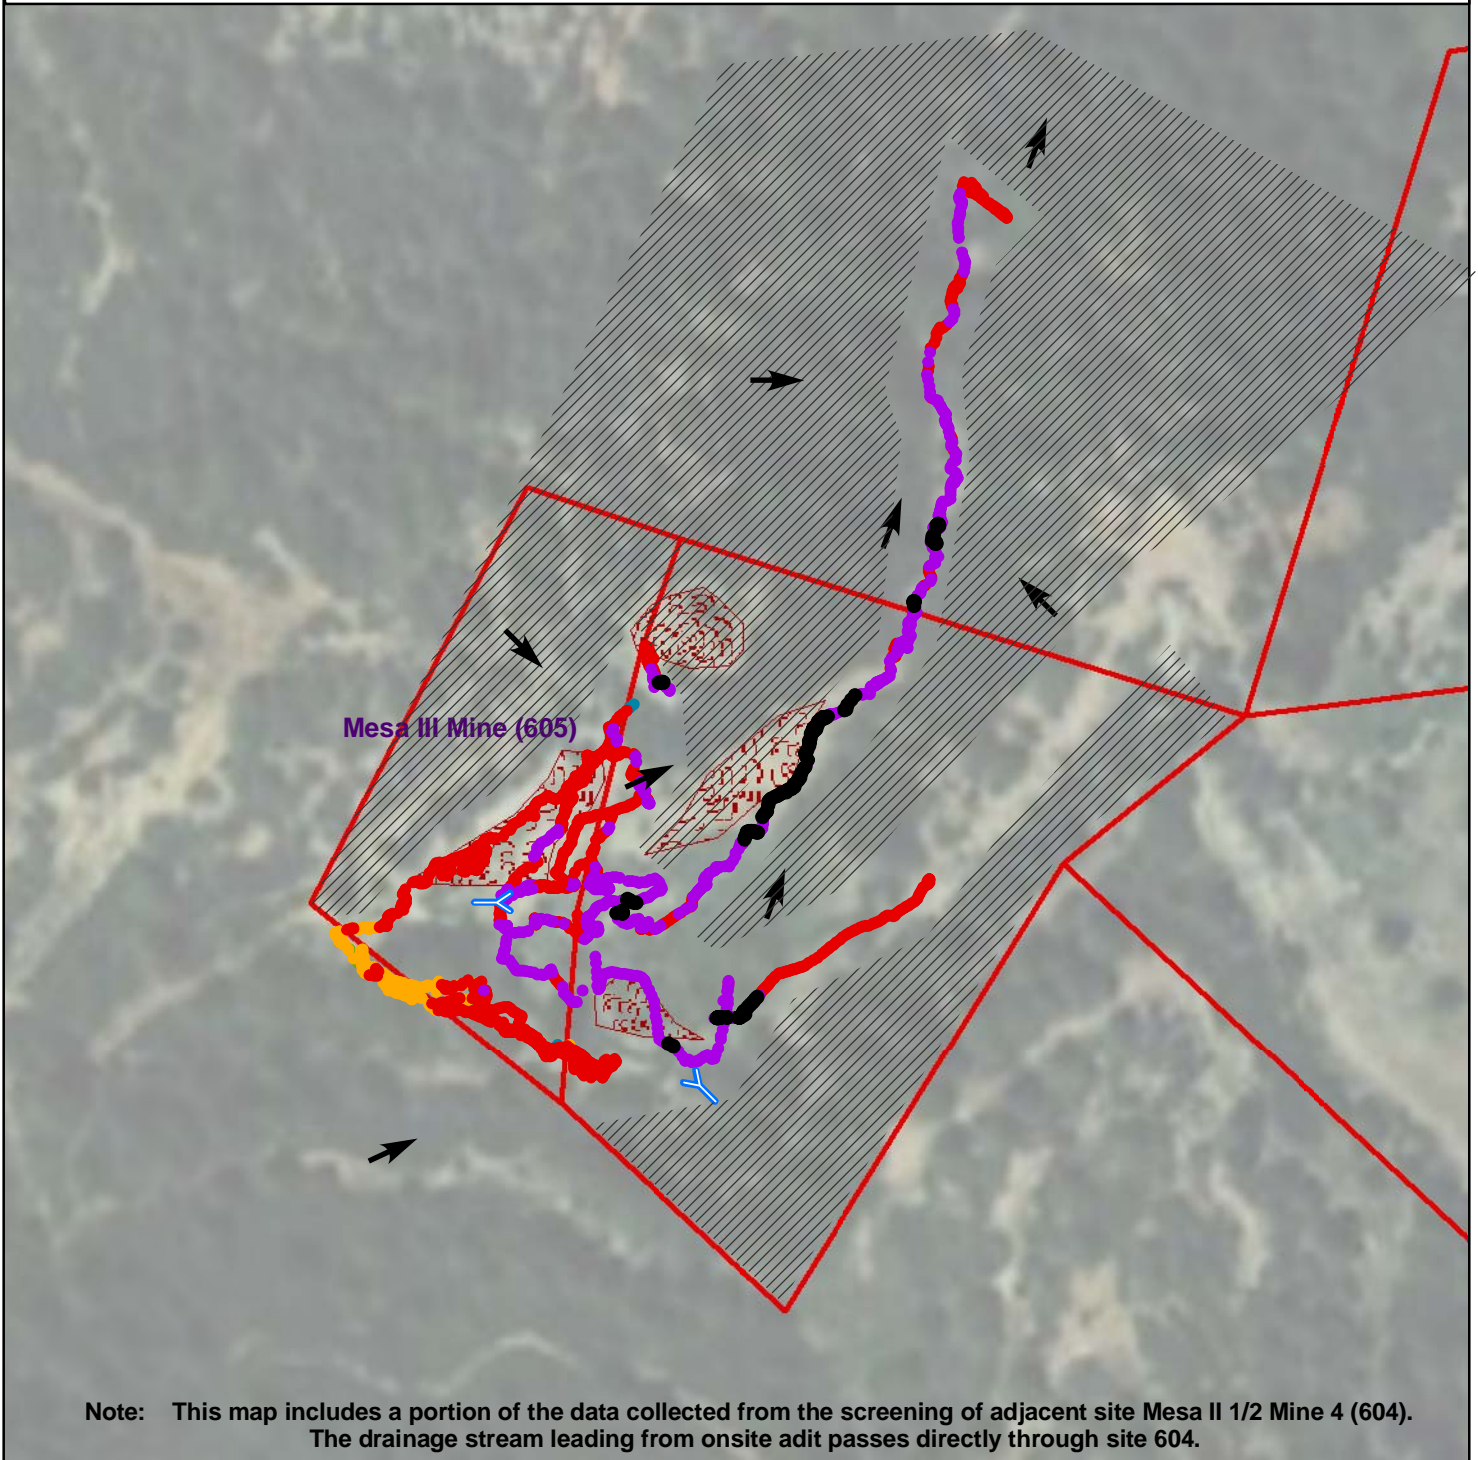
**Figure 2 - Gamma Radiation Measurements
Mesa III Mine (605)
Cove Chapter, Navajo Nation, Arizona**

Gamma survey conducted 10/2009
Measured as counts per minute (cpm)

Average background = 10,289 cpm
